# REPORT ON THE GEOHYDROLOGICAL ASSESSMENT UPDATE AT THE GWAING LANDFILL EXTENSION AREA

*Technical Report*

Veltwater Groundwater Specialists (Veltwater) was contracted by UMD Environmental Services (hereafter also referred to as the “client”) to update the existing geohydrological site assessment with additional soil sampling at the proposed extension area of the Gwaing Landfill, George, Western Cape Province.

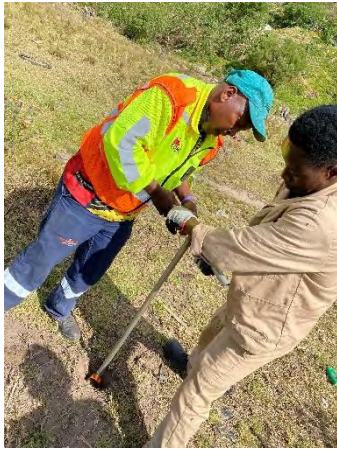
| Auger Hole ID | Total Depth | Groundwater Encountered | Sample No. | Additional Comments or Observations |
|---|---|---|---|---|
| AH6 | 1.15 | No | SS6 | Downstream of WWTW, open area, yellow-brown clay |

| Sample | Depth | Soil Texture | Consistency | Structure | Key Contaminants | Migration Potential | Motivation |
|---|---|---|---|---|---|---|---|
| <b>SS6</b> | 1.15 | Clay/silt (fine) | Firm to stiff | Intact, pinholed, shattered | Al, Fe | Low | Dense clay likely restricts vertical migration - acting like a barrier |

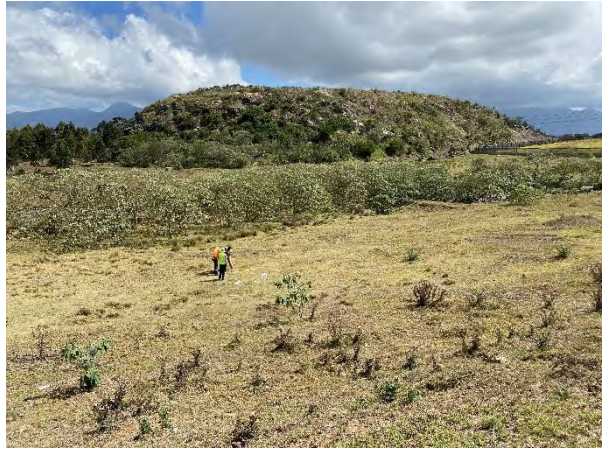
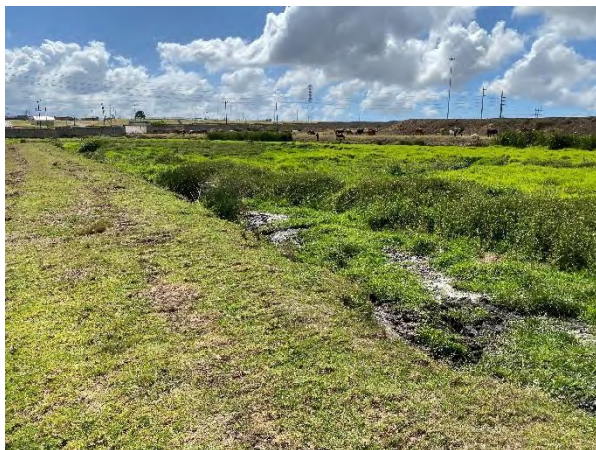
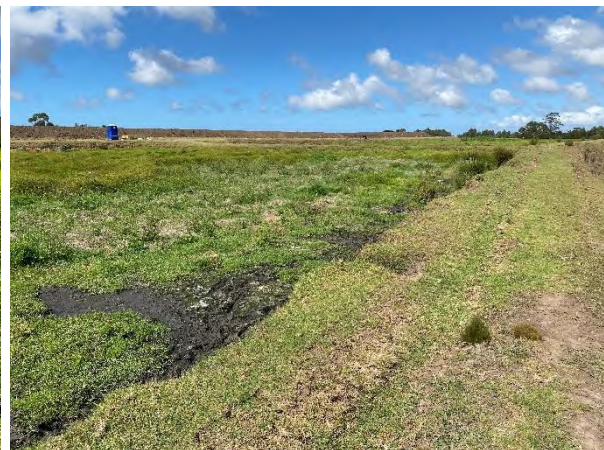
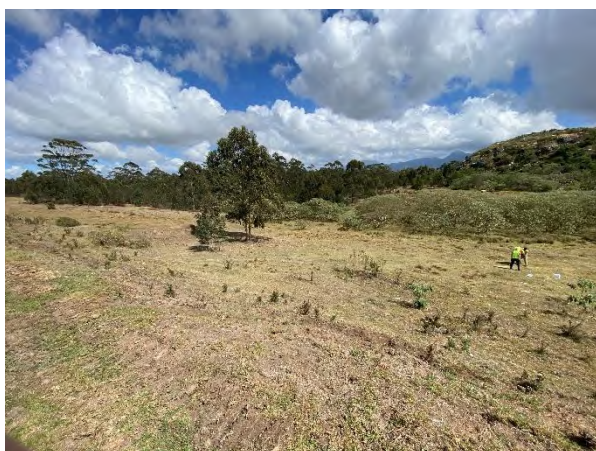
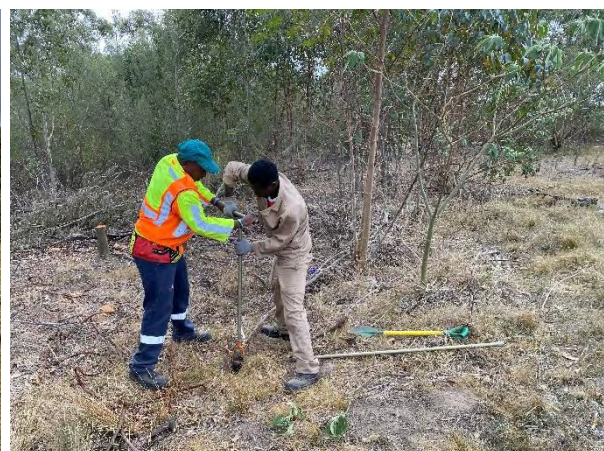
SS7 View to the North

| Auger Hole ID | Total Depth | Groundwater Encountered | Sample No. | Additional Comments or Observations |
|---|---|---|---|---|
| AH7 | 0.65 | No | SS7 | Downstream of WWTW, open area, loose sand, refusal reached |

| Sample | Depth | Soil Texture | Consistency | Structure | Key Contaminants | Migration Potential | Motivation |
|---|---|---|---|---|---|---|---|
| <b>SS7</b> | 0.65 | Sand, silt (fine) | Very loose | Intact, no clay | Fe, P | Moderate | Loose sandy texture may allow migration, but no major exceedances |

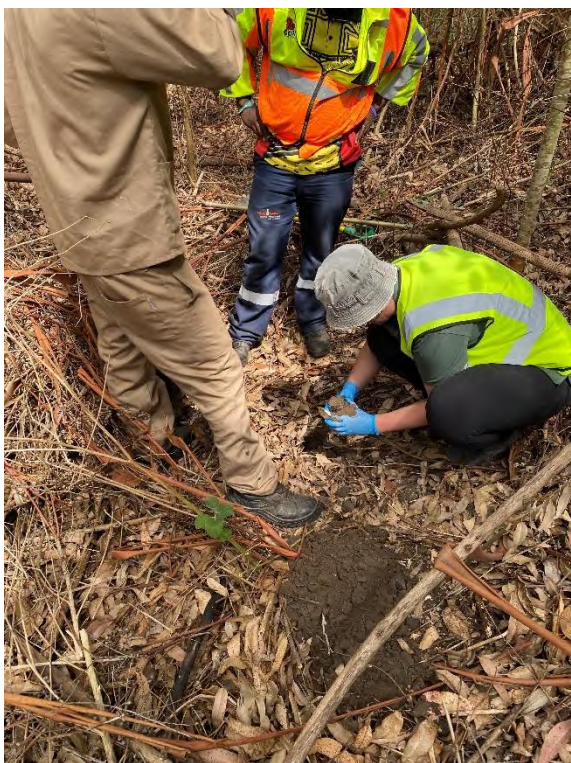
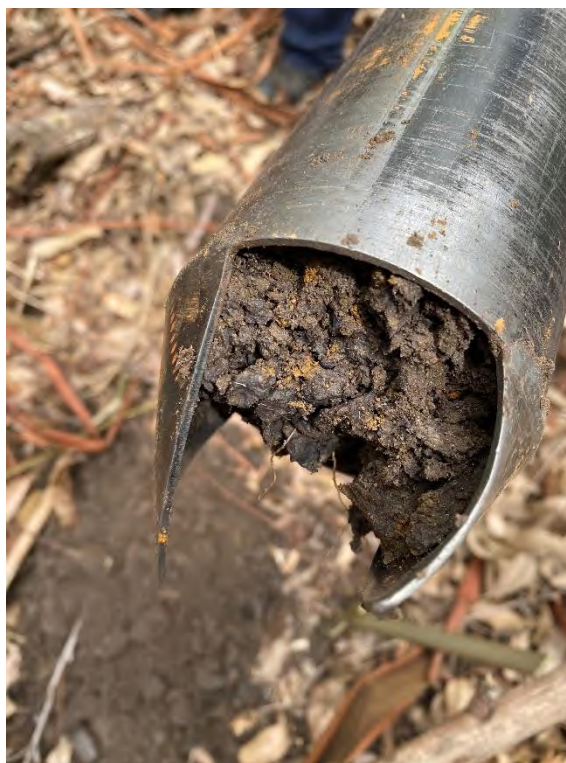
| Auger Hole ID | Total Depth | Groundwater Encountered | Sample No. | Additional Comments or Observations |
|---|---|---|---|---|
| AH8 | 0.34 | No | SS8 | Downstream of landfill and WWTW, open area, near the treeline, shallow drainage line, sand & gravel |

| Sample | Depth | Soil Texture | Consistency | Structure | Key Contaminants | Migration Potential | Motivation |
|---|---|---|---|---|---|---|---|
| <b>SS8</b> | 0.34 | Sand, silt (fine) | Very loose | Intact, no clay | As, Pb, Al, Fe, TOC | High | Loose sandy matrix at shallow depth with major exceedances - high migration potential vertically and laterally |

SS8 and SS9 showed the most evident contamination, suggesting surface or near-surface leachate impact. SS8 was sampled at a shallow depth of 0.34 mbgl within a shallow drainage line and shows the highest concentrations of As, Pb, Al, Fe, and TOC, and SS9 was sampled at a depth of 0.99 mbgl with elevated concentrations of F, Al, Ca, Fe, Mg, K, and TOC. These elevated concentrations could be attributed to increased infiltration from overland flow during rainfall events, due to position of SS8 within the drainage line.

Annual soil sampling should be undertaken at the identified hotspots (SS8 and SS9) and downslope locations (SS10 and SS11) to confirm the absence of plume migration. This monitoring will track changes in As, Pb, F, Al, Fe, and TOC concentrations over time and will allow early detection of any lateral or vertical contaminant movement. Results will be used to verify that no new risks to groundwater or surface water are developing and to trigger additional investigation or mitigation if upward trends or exceedances are observed.

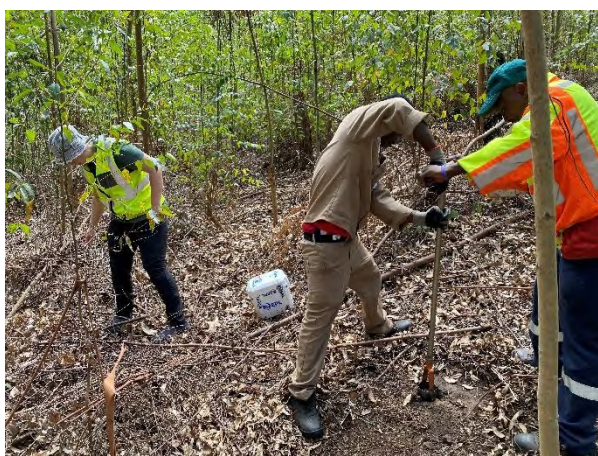
| Auger Hole ID | Total Depth | Groundwater Encountered | Sample No. | Additional Comments or Observations |
|---|---|---|---|---|
| AH9 | 0.99 | No | SS9 | Natural woodland area, drainage line, dark brown topsoil |

| Sample | Depth | Soil Texture | Consistency | Structure | Key Contaminants | Migration Potential | Motivation |
|---|---|---|---|---|---|---|---|
| <b>SS9</b> | 0.99 | Sand, silt (fine - medium) | Loose (sand), firm (clay) | Intact, shattered | F, Al, Ca, Fe, Mg, K, TOC | Moderate - High | Mixed texture. Firm clay may slow vertical migration, but shattered structure may allow lateral flow potential along interfaces, especially for F and TOC. |

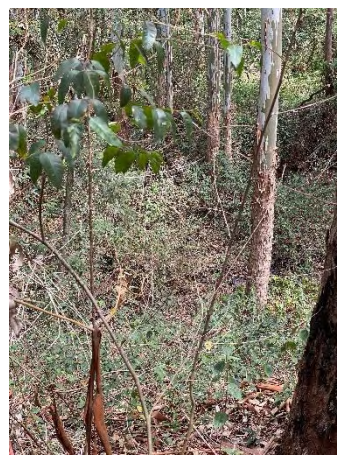
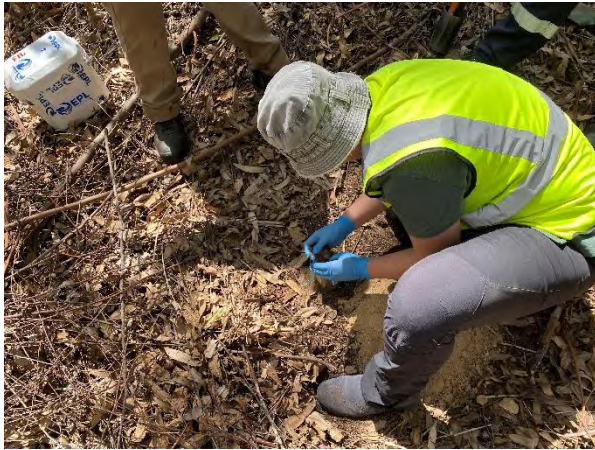
| Auger Hole ID | Total Depth | Groundwater Encountered | Sample No. | Additional Comments or Observations |
|---|---|---|---|---|
| AH10 | 0.64 | No | SS10 | A few metres from the Gwaing River. Riverine and woodland area with thick wood carpet, refusal - weathered granite |

| Sample | Depth | Soil Texture | Consistency | Structure | Key Contaminants | Migration Potential | Motivation |
|---|---|---|---|---|---|---|---|
| <b>SS10</b> | 0.64 | Weathered granite cobbles | Very loose | Intact, pinholed, no clay | Fe, Mg, K, TOC | High | Very loose, coarse matrix with abundant clasts - leachate migration |

Downslope samples (SS10 and SS11) towards the river, didn't show any exceedances and were found compliant compared to the chosen standards.

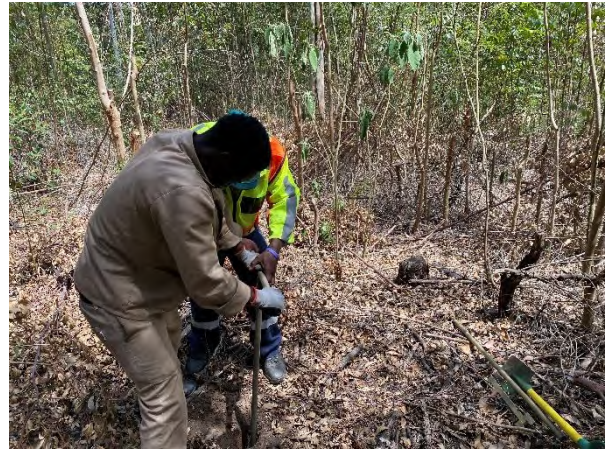
| Auger Hole ID | Total Depth | Groundwater Encountered | Sample No. | Additional Comments or Observations |
|---|---|---|---|---|
| AH11 | 0.85 | No | SS11 | Natural woodland area, thick wood carpet, refusal - weathered granite |

| Sample | Depth | Soil Texture | Consistency | Structure | Key Contaminants | Migration Potential | Motivation |
|---|---|---|---|---|---|---|---|
| <b>SS11</b> | 0.85 | Weathered granite gravel | Very loose | Intact, pinholed, no clay | Al, Fe, Mg, K | High | Very loose gravelly matrix promotes contaminant movement |

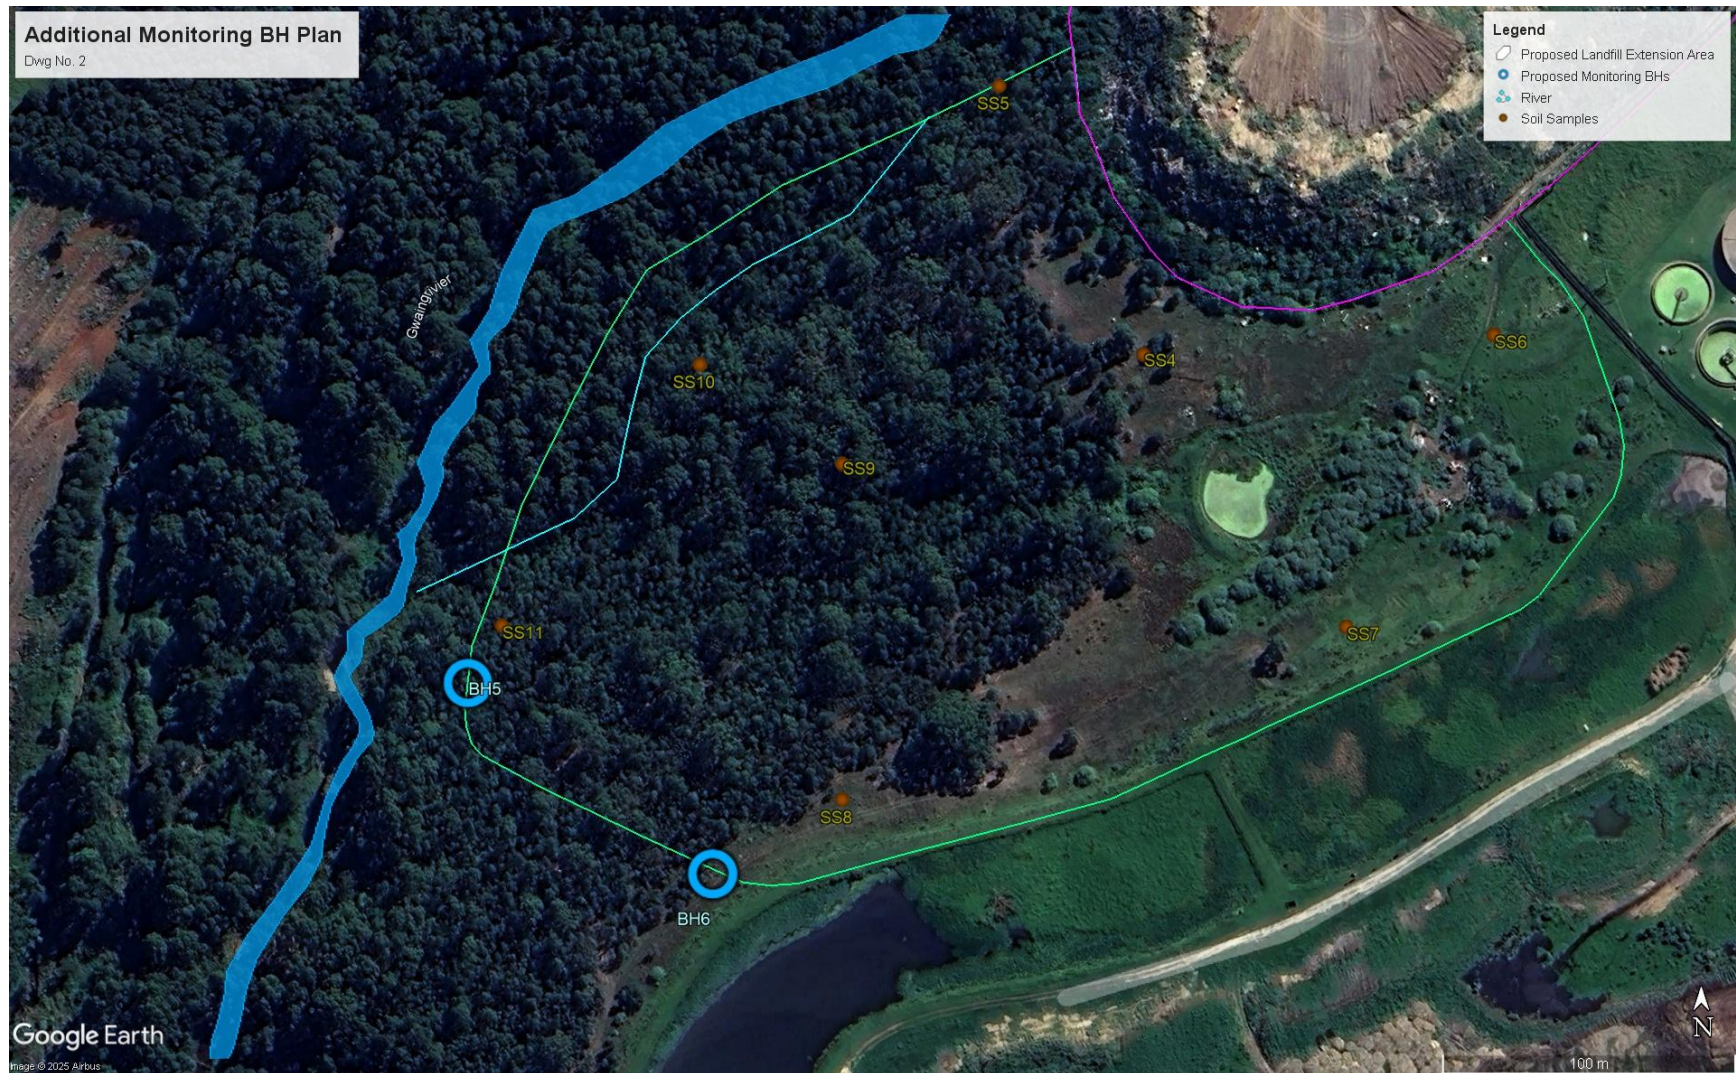
Dwg No. 2 – Additional Monitoring BH Plan

It is recommended that at least two (2 x down-gradient), additional monitoring boreholes be installed, of which the proposed locations were provided in the attached Proposed Additional Monitoring Borehole Plan – Dwg No. 2. This will allow for the effective monitoring of the groundwater quality.
